UDC 624.21:69.059(498)

TECHNIQUES FOR SPECIAL FOLLOWING OF THE DEGRADATIONS DEVELOPMENT FOR A RAILWAY PASSAGE

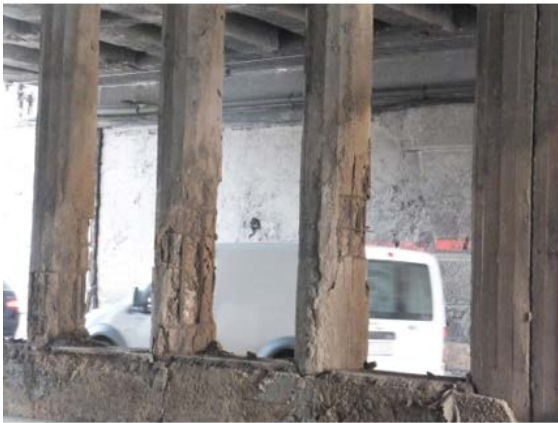
Figure 4. The Constanța Bridge pier before rehabilitation works.

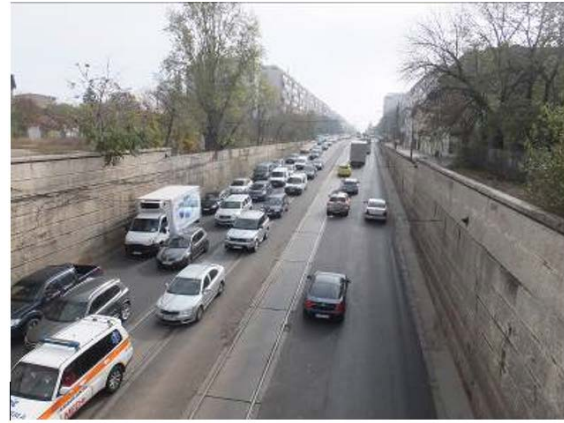
Figure 5. Traffic jam at the entrance of passage.

-The road traffic is very heavy (Figure 5), this being due to the clear passage height under the bridge, and the passage lighting is only designed for 2 lanes of road traffic in each direction and 2 tram lines. On the passage area, Griviței Road has undergone a series of expansions over time, currently having 3 lanes of traffic in each direction and 2 tram lines.

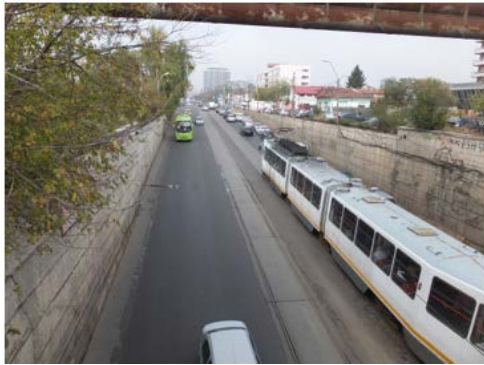
- The tram traffic (Figure 6) through the passage generates strong vibrations in the immediate vicinity of the pile, which has led to multiple deteriorations, including the safety structure of the passage.

Figure 6. The tram traffic in the passage.

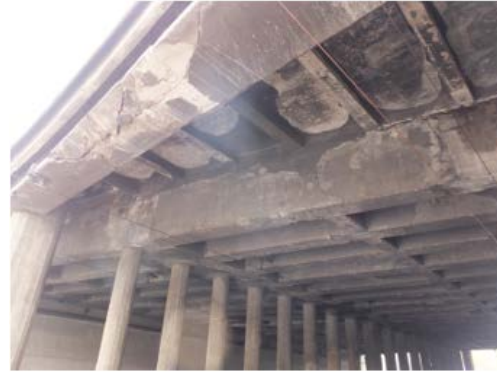
Figure 7. The marginal girder.

-The marginal beams have numerous signs of impact due to the violation of the safety height (Figure 7).

-Due to advanced age and repeated impacts, the reinforcement at the bottom fiber of the girder is exposed, rusty, some of the reinforcing bars are even broken, which leads to a pronounced decrease in the carrying capacity of the girder and, implicitly, the entire structure.

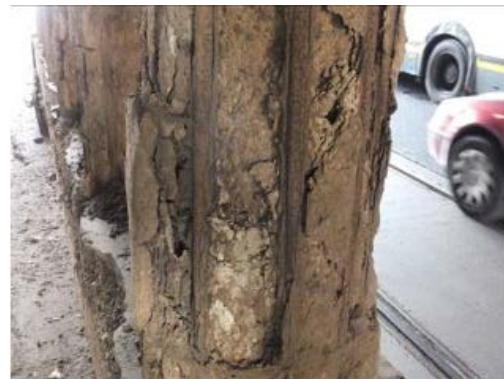
-The pillar supports show severe degradation of the concrete cover layer, with reduction in section, complete corrosion of reinforcing steel, cracks oriented along the elements, and friable concrete (Figure 8).

-The elevations of the piers and abutments are severely degraded, with extensive areas of fallen plaster, segregated concrete, voids, and exposed reinforcement.

Figure 8. Degradations of the pillar support [6].

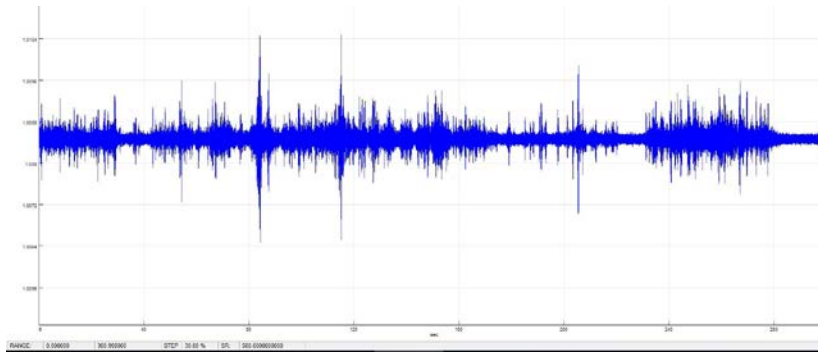
The monitoring system for the vibration evolution of the bridge under traffic loads has revealed serious resistance problems of the bridge. The vibration modes varied from the expected and calculated ones during the design phase of the system.

The main causes of structural vibrations were the trams and trolleybuses passing through the bridge. These generated the largest dynamic loads that propagated to all structural elements, as seen in Figure 19.

Figure 19. Evolution of structural vibrations.

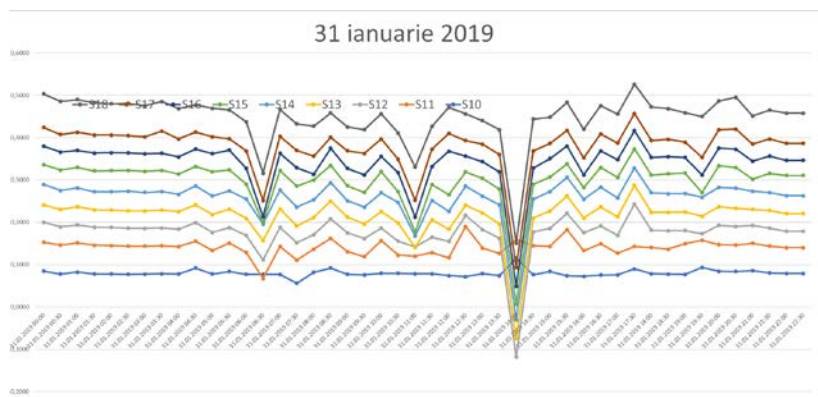
Additionally, the monitoring system was able to capture the structure's reaction to an earthquake recorded on January 31st, 2019. As such, the evolution of vibration mode graphs (Figure 20) shows a significant jump. At the same time, the monitoring system alerted the monitoring team about the situation.

After analysing the cause of the jump, the monitoring team was unable to find any structural explanation, learning from the media that the earthquake occurred in the Vrancea area and the waves propagated towards Bucharest. Thus, the effectiveness of the concept in alerting the occurrence of situations with a high potential risk for users was demonstrated.

Figure 20. Recording of the earthquake on 01.31.2019.

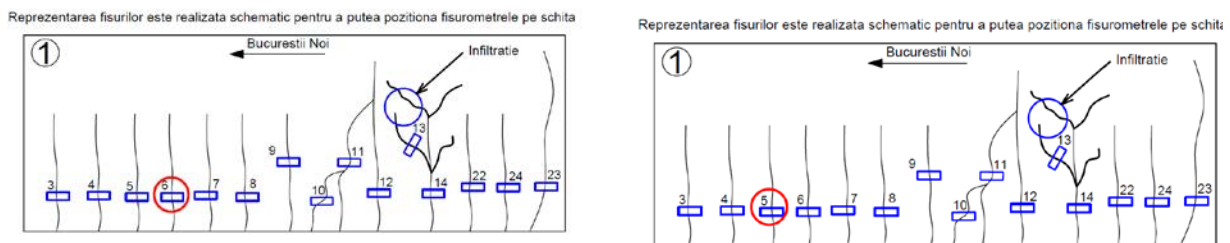
Regarding the monitoring of crack evolution, as shown in Figure 21, it was identified a significant settling at both piers, on the side towards Calea Griviței, highlighted by the opening of cracks on the right side of the piers and their ascending evolution. The settling occurred immediately after the earthquake on 01.31.2019.

Figure 21. Evolution of cracks.

7. It is recommended to carry out the consolidation and rehabilitation works of the bridge as soon as possible to avoid severe degradation of the structure in case of a strong earthquake that would force the closure of the bridge's circulation.
