# Study of the Titanium Alloys Surfaces Used in Orthopaedic Systems

**Abstract** — Total hip prosthesis (THP) is a highly successful orthopaedic device. However, its durability is generally limited to a few decades due to difficult conditions in the human body and huge demands it is subjected to. A hip prosthesis is deteriorating due to high surface pressures caused by mechanical movements of the body.

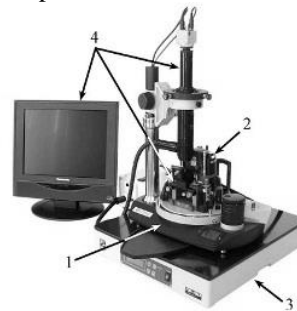
Fig. 2. NTEGRA Probe NanoLaboratory: a) 1 – base unit; 2 – measuring head; 3 – vibration isolation system; 4 – optical viewing system.

We realized topography of hip prostheses components by atomic force microscopy (AFM), because its images display high quality and dense nanocrystalline structure of the surfaces. An atomic force microscope (NTEGRA Probe Microscope – Fig. 2) working in the noncontact mode was used in our experiments. It is composed of a base unit where we have the sample, a special measuring head made of a cantilever with a pointed end, and an

optical viewing system. AFM images are processed using Nova SPM software. In this way, tribological parameters that offer information about the uniformity of femoral heads surfaces were obtained, like:

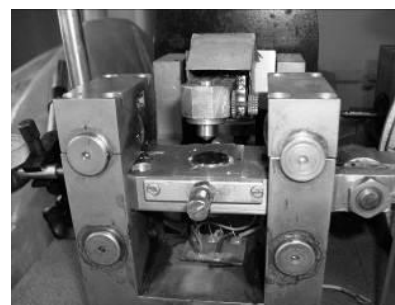
Fig. 3. General view of scratch tester.

Adhesion resistance of deposited TiN layers was evaluated by scratch testing with the system presented in Fig. 3. This system has a diamond spherical tip and the movement is pure sliding. The tested body is the 316L stainless steel disks coated with TiN. The applied loads were in the range of (2.5 – 125) N. Each scratch was analysed at the end by optical microscopy (OM) and AFM.

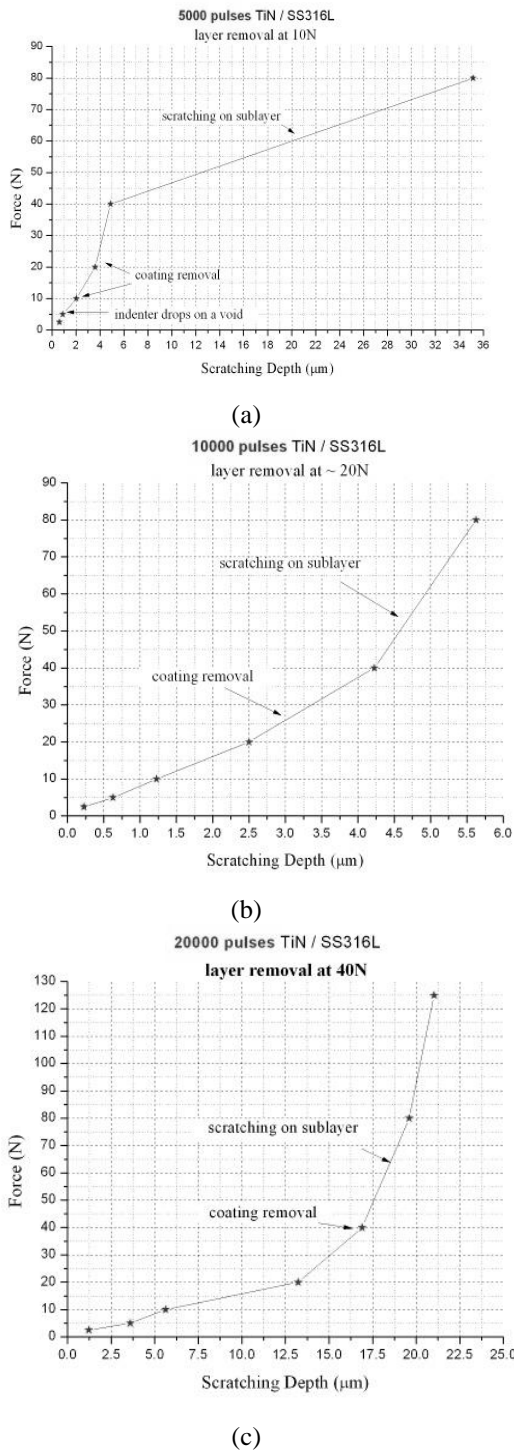
Fig. 9. Variation of scratching depth ( $\mu\text{m}$ ) function of normal load applied over the indenter (N), on SS316L samples, coated with TiN by PLD, (a) at 5000 pulses, (b) 10000 pulses and (c) 20000 pulses, respectively.

Width and depth of the scratches were measured by OM and AFM. Graphic variation curves of scratches depths depending on the applied normal load were drawn.

On the OM images were measured in ten places scratch traces widths, then were calculated their depths *h* based on a simplified relationship (indent method), which takes into account the radius of diamond tip (*r*) and the means values of measured widths of the indent (*l*):

$$h = l / 8r. \quad (1)$$

Variation curves of scratching depth function of applied normal load (Fig. 9) show some "indenter drops" due to indentation on voids or other defects of coatings.
