UDC 624.21:69.059(498)

TECHNIQUES FOR SPECIAL FOLLOWING OF THE DEGRADATIONS DEVELOPMENT FOR A RAILWAY PASSAGE

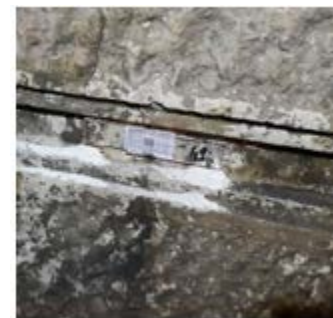
Figure 10. Glass marker for monitoring crack evolution.

- At the location of cracks affecting the pier piles (Figure 10), to highlight the stress state and crack evolution over time, determining if the crack is active or passive. For better data accuracy, at least 50% of cracks will be monitored.
- In the case of cracks affecting the main beams, due to their importance, all cracks will be monitored, following their evolution under traffic, regardless of the cause of appearance and position (cracks in the bearing area due to shear force or cracks in the central area due to bending moment).

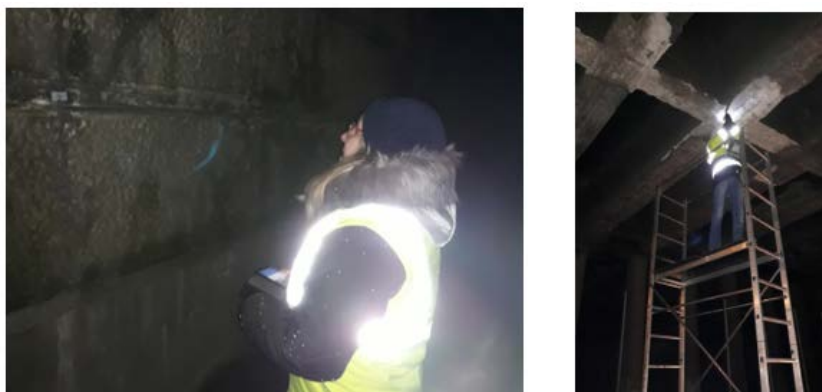
The ScanLog5+ level was used for all piles (Figure 16), one of the columns, and a beam, easily analysing the structure's reinforcement, degree of degradation, and concrete coverage. The determination took place during a site visit on 12/19/2018, targeting the structure's characteristic areas.

Figure 16. Data capture for structural reinforcement.

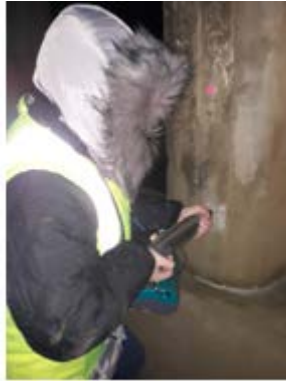
The concrete compressive strength was determined for all piles, 2 main girders, column elevations (Figure 17) and bridge wings. This determination becomes a key factor in decision-making regarding the rehabilitation work to be performed, as concrete is one of the most important building materials and the available strength determines the chosen rehabilitation solution and type of materials to be used.

Figure 17. Determination of the compressive strength of concrete in pile columns.

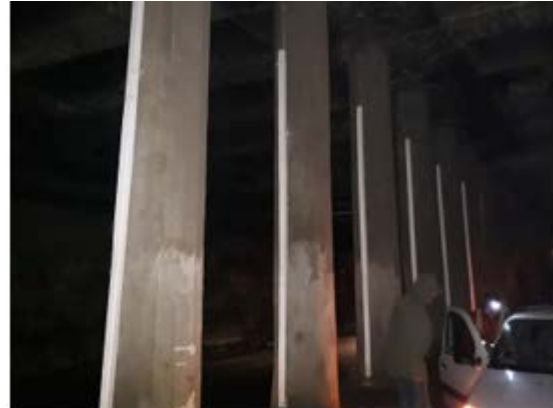
Figure 18. Installation of optical fiber at the pile column.

Optical fiber was installed at each pile column (Figure 18). The main goal was to record the structure's behavior under traffic.
